**MBA – WINNER CIVIL ENVIRONMENTAL MANAGEMENT  
PROJECT - 2011**

**HMAS HARMAN REMEDIATION**

HMAS Harman – New Building Project – Contamination Remediation

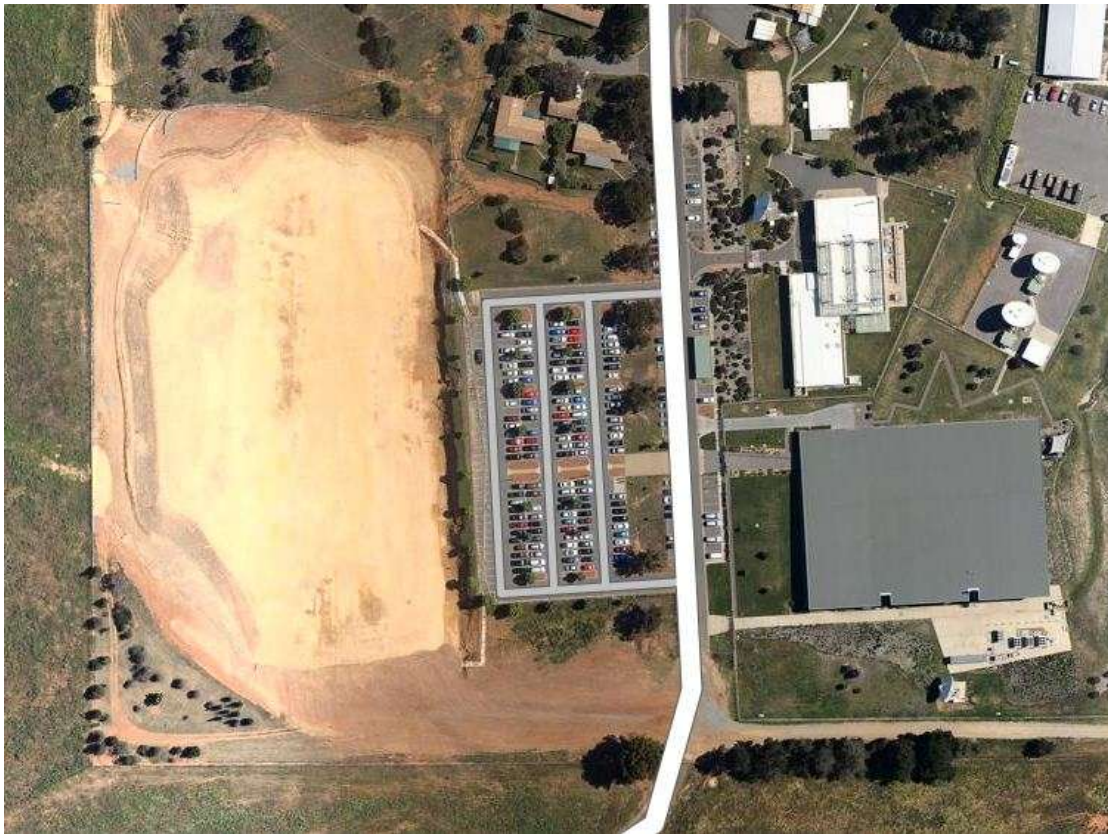
Completed site - November 2010 (sourced from Google Earth)
